Scope of Works Proposal Ref: GSQU-0366

Shire of Moora

Pump Station 5 Pressure Main Reline

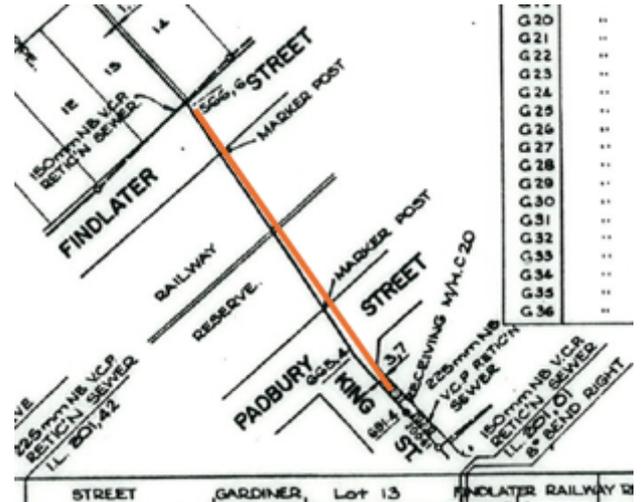
A section of the pipe runs underneath industrial rail between Findlater St and Padbury St leading to the discharge chamber.

A sense of priority would be to start by rehabilitating the pipe section from the discharge chamber to the fence line of the properties backing onto Findlater St. This is due to the impact on the rail in the chance event there was a failure of the pressure main. Approximately 125m of AC pipe.

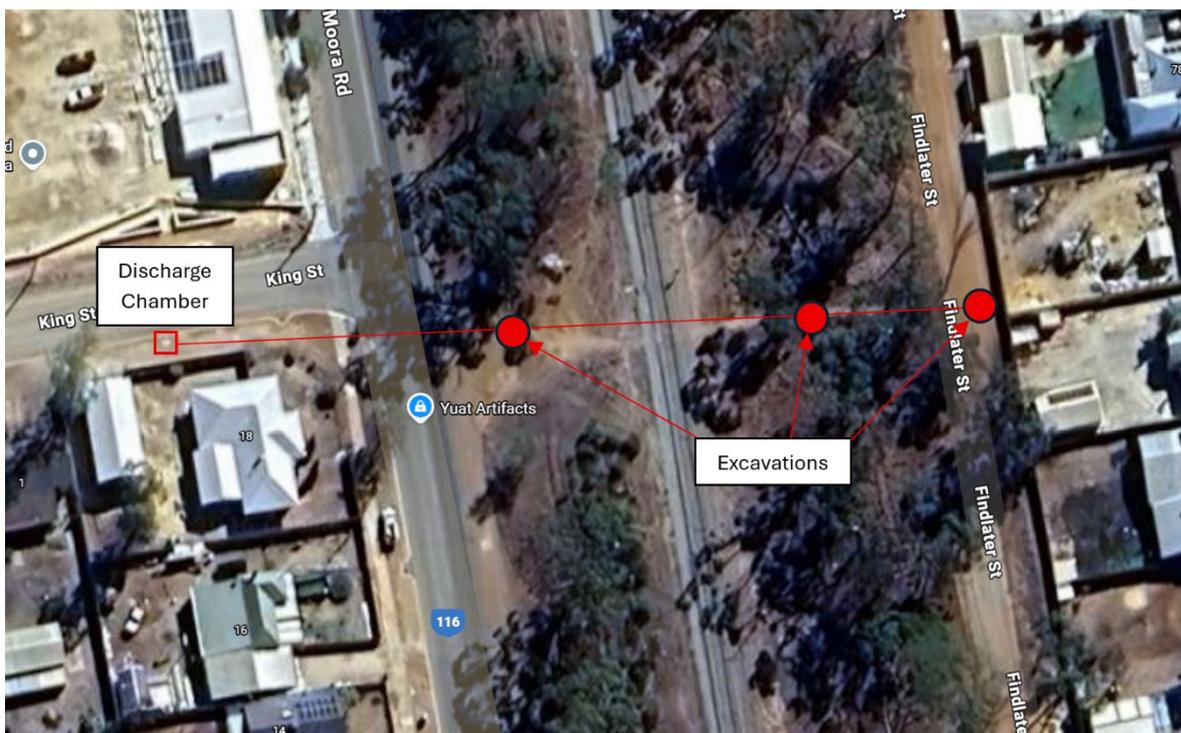
The liner will be installed in 3 sections as shown in the plan below. 3 excavations are required to cut into the pipe to allow installation of the pipe liner. Once the liner is installed, the rehabilitated pipe is reconnected with gibbaults.

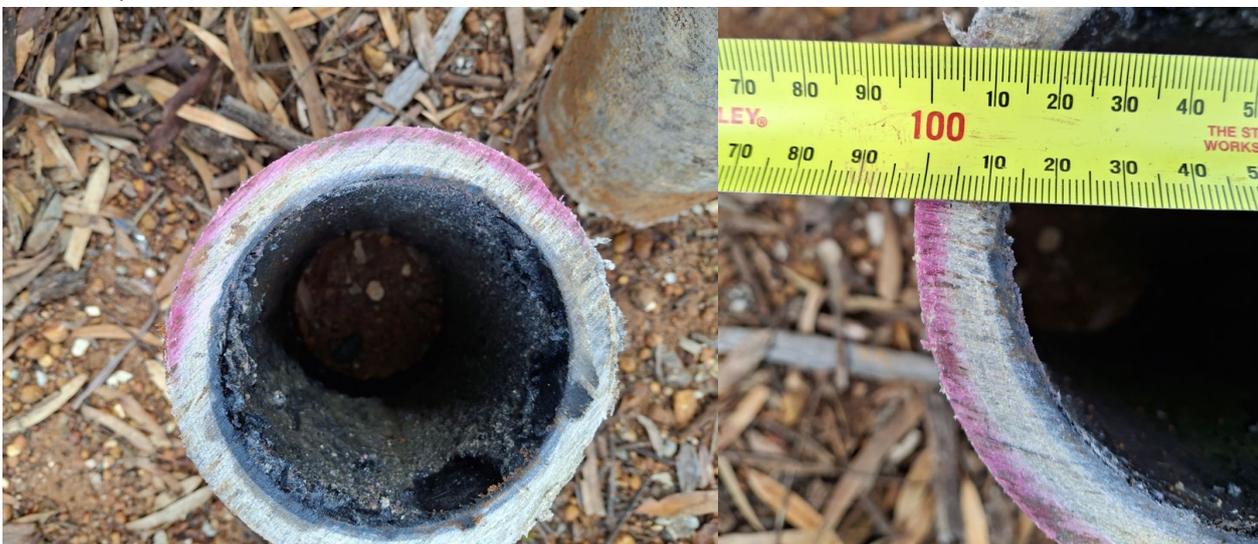
Test photos

Alkalinity testing was performed on the AC pipe sample to determine the remaining effectiveness of the cement. Phenolphthalein solution, applied to a freshly broken edge of the sample, is used as a pH indicator to determine whether the profile of the cross-sectional face of the pipe is above a pH of approximately 10—where this is the case, a colour change will occur. A reduction in pH indicates leaching of calcium silicate and calcium hydroxide. In this case the tests showed that the pipework had fully leached on most of the pipe and 85-90% with little remaining on the top third of the pipe. See photos below.

Assumptions can be made for the rest of the asset, being in the same condition as the conditions are unlikely to vary significantly. The testings show remaining strength is very poor and that the asset is very close to, or at the end of its life.

Following testing of the DN100 AC pressure main leading from wastewater pump station 5 it was found that the pipe is in very poor condition. Goodstream proposes to install an internal pipe liner to extend the life of the pipe to a minimum design life of 50 years.
