**SHIRE OF MOORA
LOCAL PLANNING SCHEME NO.4**

NOTICE OF PUBLIC ADVERTISEMENT OF PLANNING PROPOSAL

Lot 80 (No.18201) Great Northern Highway, Miling

CHANGE OF USE TO WORKFORCE ACCOMMODATION AT LOT 80 (NO. 18201) GREAT NORTHERN HIGHWAY, MILING

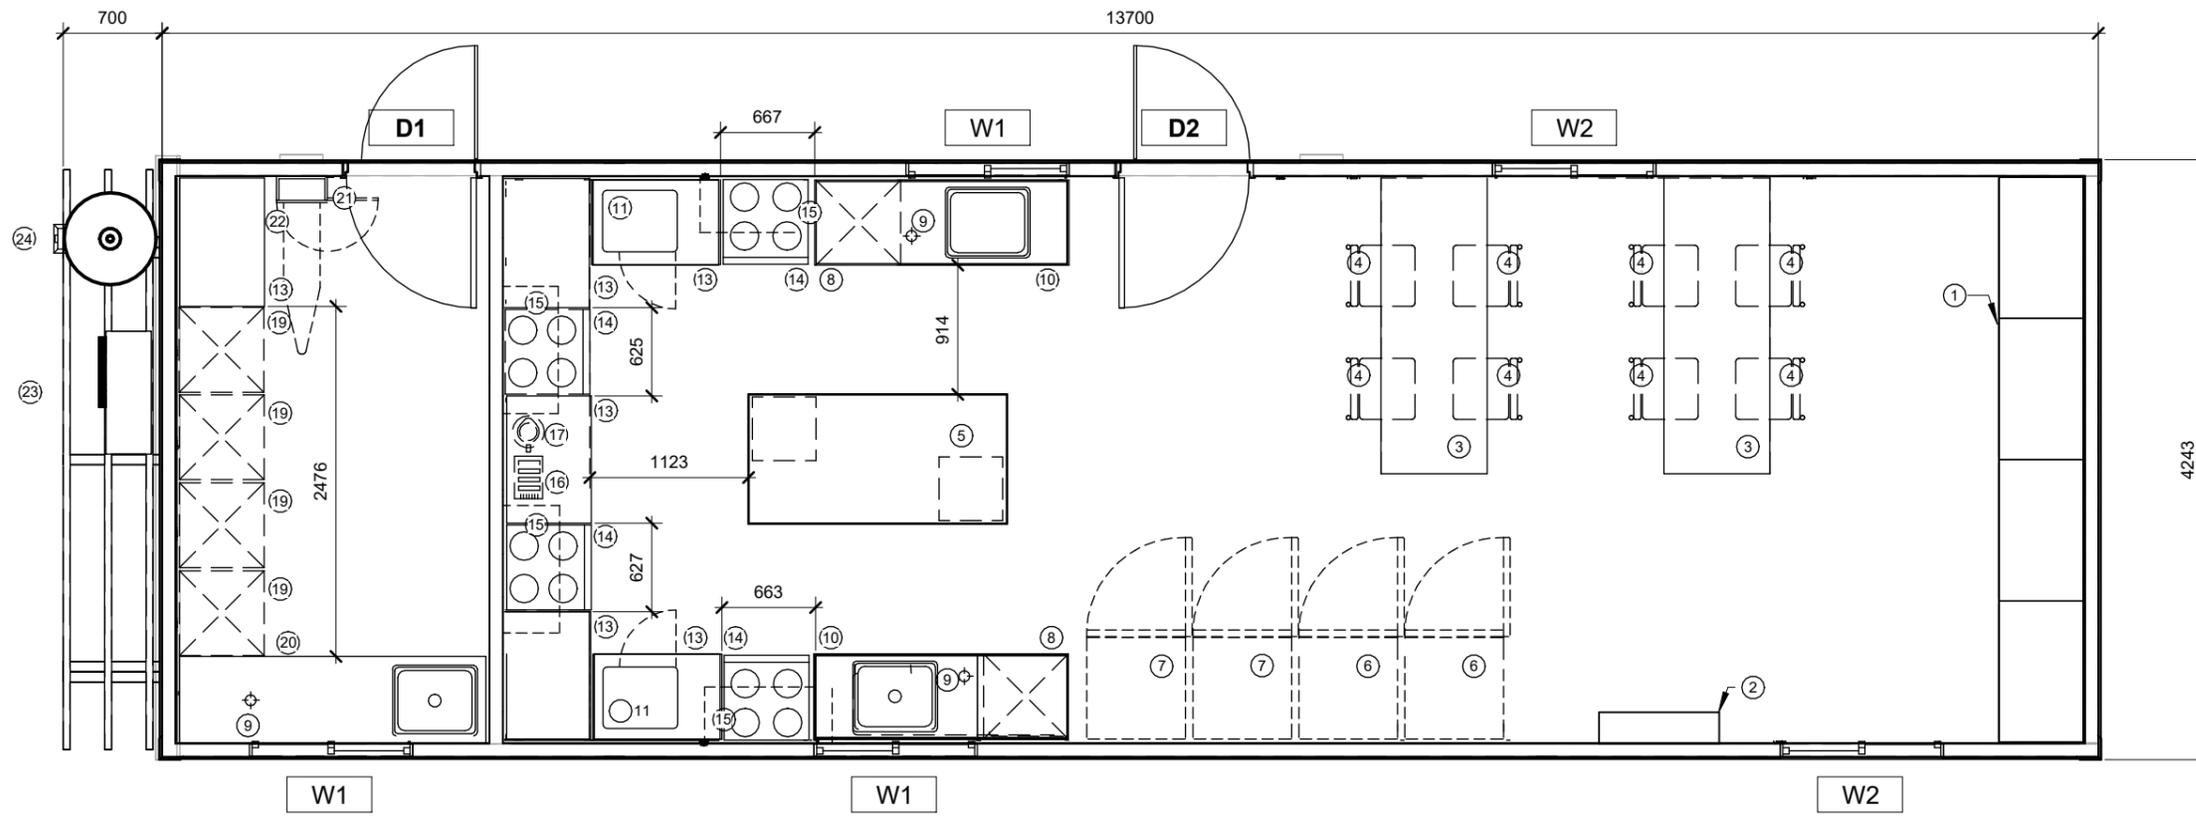
General Arrangement
 1 : 50

EQUIPMENT LIST
1. 2200mm high white melamine cupboards w 5 adjustable shelves
2. AC Wall Mounted Unit
3. Table (Supplied by CBH)
4. Chair (Supplied by CBH)

5. Stainless steel bench with 2 sets of 2 lockable drawers on opposing corners as per layout - 1829Lx914Wx900H
6. Nom 500L freezer (Supplied by CBH)
7. Nom 500L fridge (Supplied by CBH)

8. Dishwasher Supply - Cold water (dishwasher supplied by CBH)
9. Floor Waste
10. Stainless steel bench w intergrated sink & splashback-1800Lx610Wx900H
11. Microwave on wall mounted SS shelf (Microwave supplied by CBH)

13. Stainless steel bench - 914Lx610Wx900H
14. 4 Burner SS gas stove & oven (Supplied by CBH)
15. 900mm Cooker hood (supplied by CBH)
16. Toaster (supplied by CBH)

17. Kettle (Supplied by CBH)
19. Washing machine supply 600 wide (Washing machine supplied by CBH)
20. Stainless steel bench w integrated sink & splashback-2170Lx610Wx900H

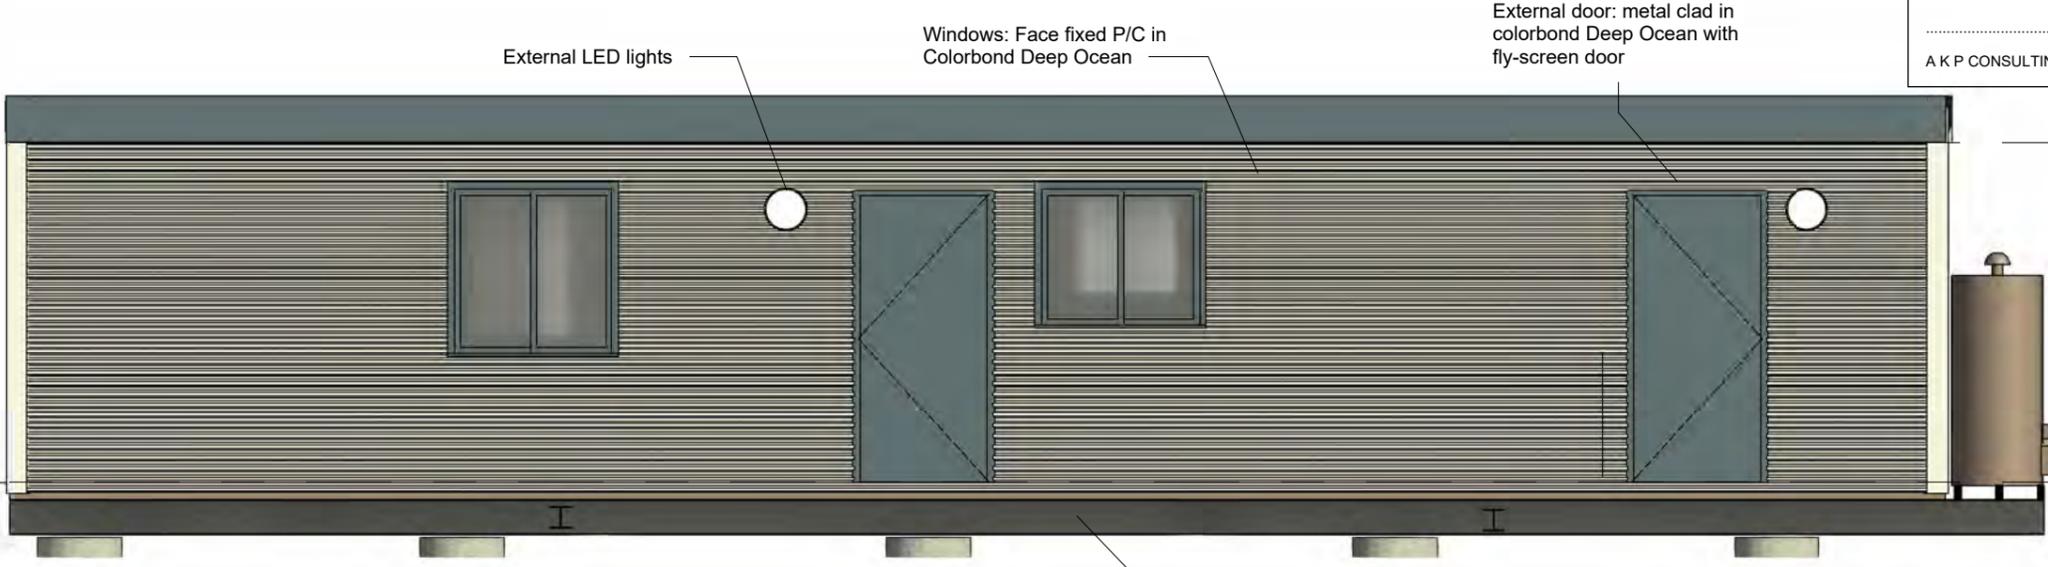
North
1 : 50

Roof cladding: Monoclad in Colorbond Deep Ocean

Structural Chassis below - see Chassis Structure plan for details

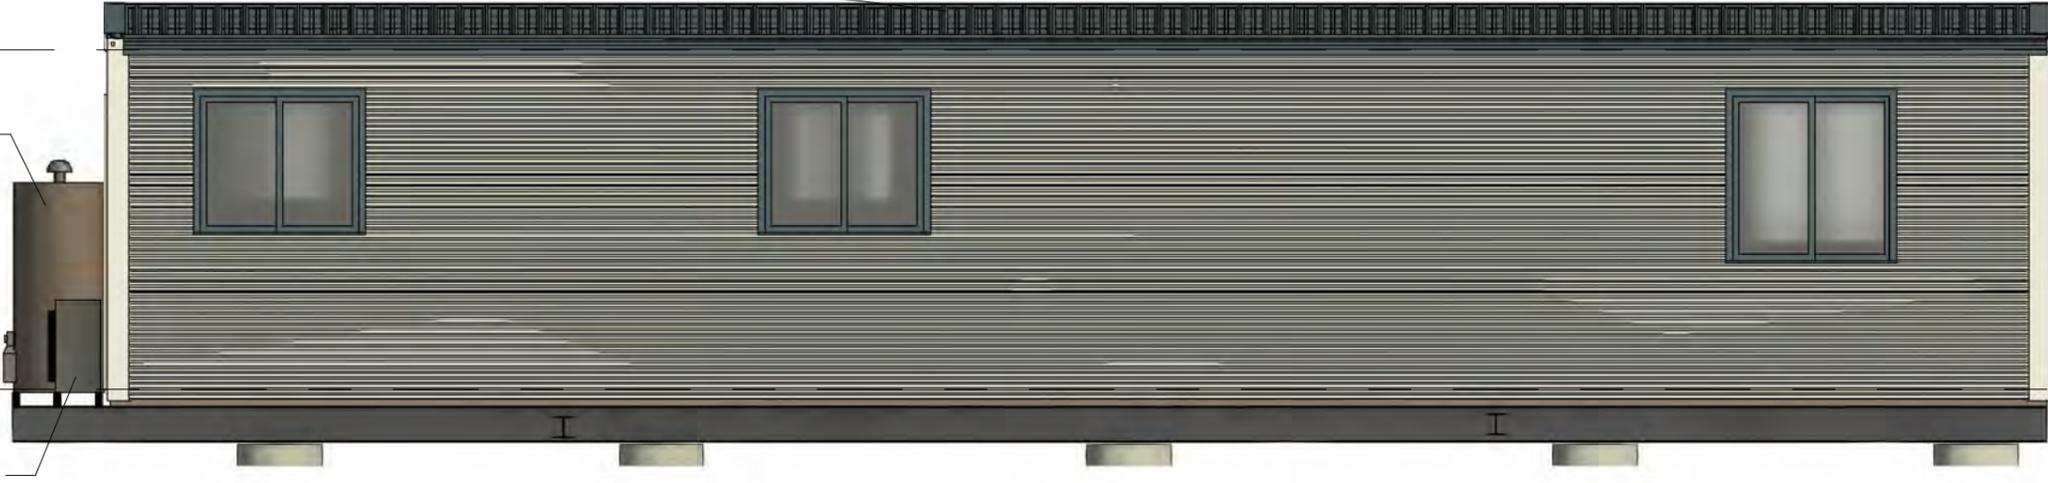
South
1 : 50

Floor Level
0

Ceiling Level
2400

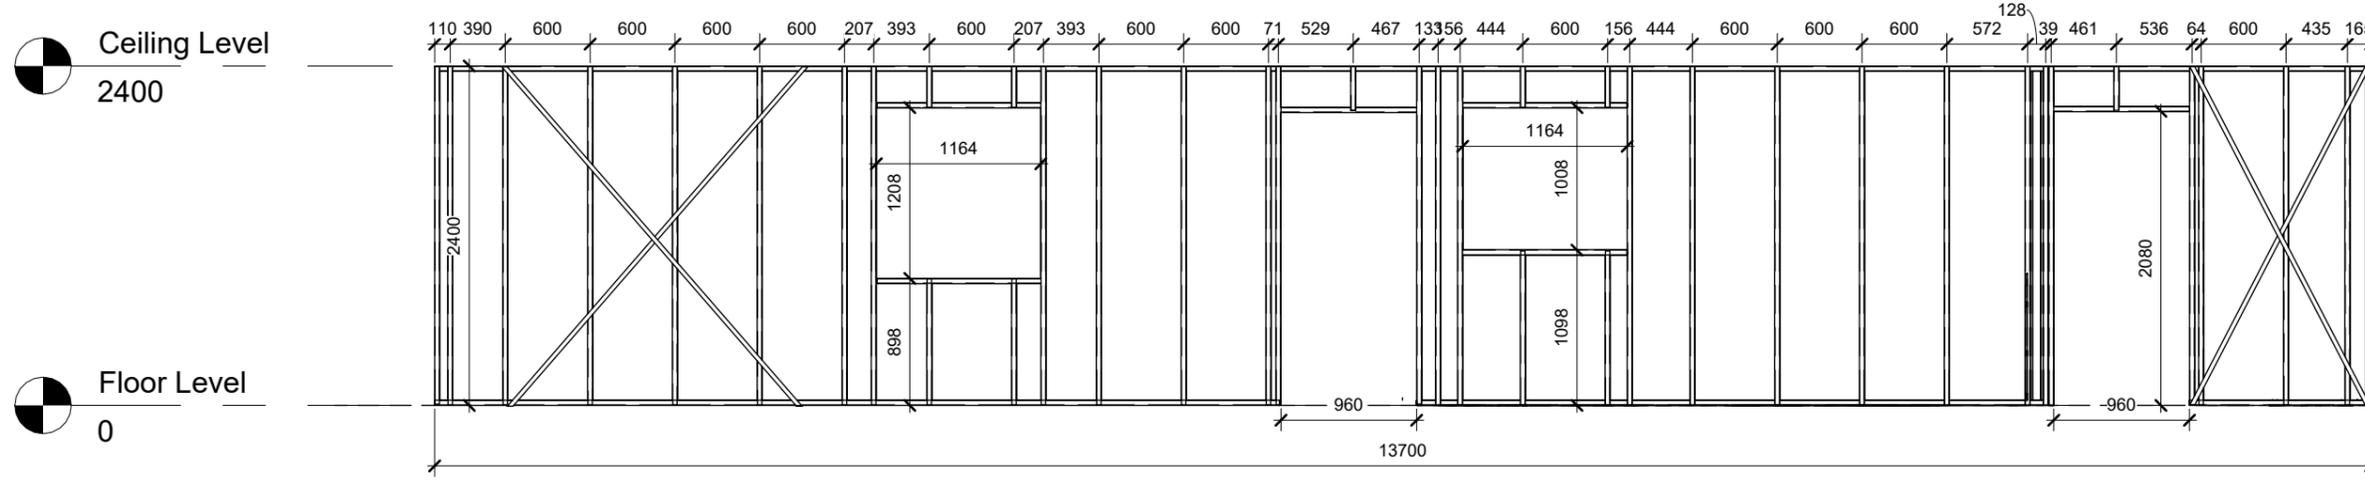
North Wall Frame
 1 : 50

NOTES
 - All stud/track framing components fixed together using drill point metal screws

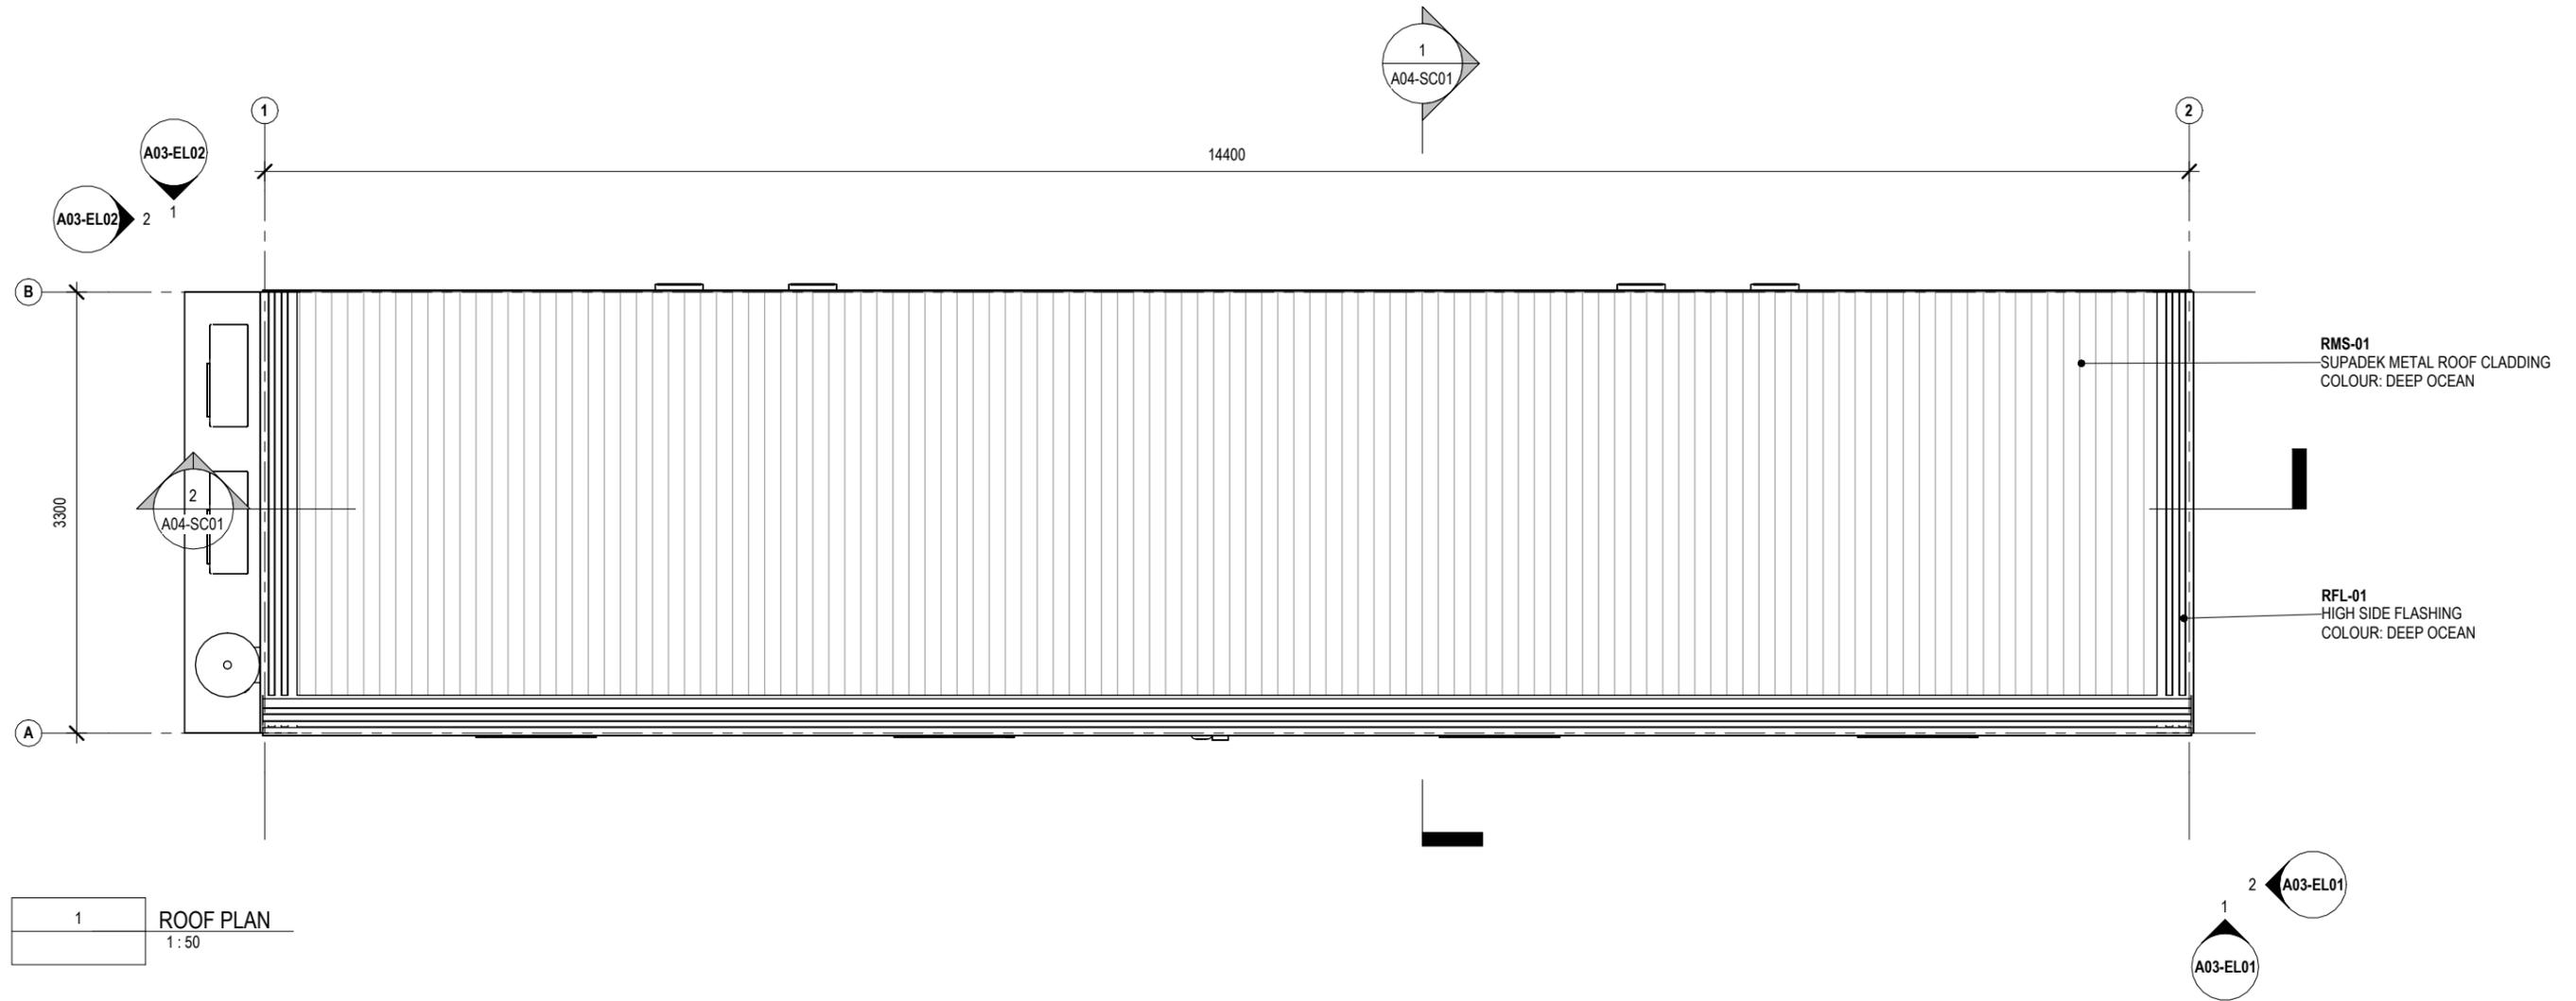
1 ROOF PLAN
1:50

METAL SHEET ROOFING TO BE IN ACCORDANCE WITH AS1562.1-1992.

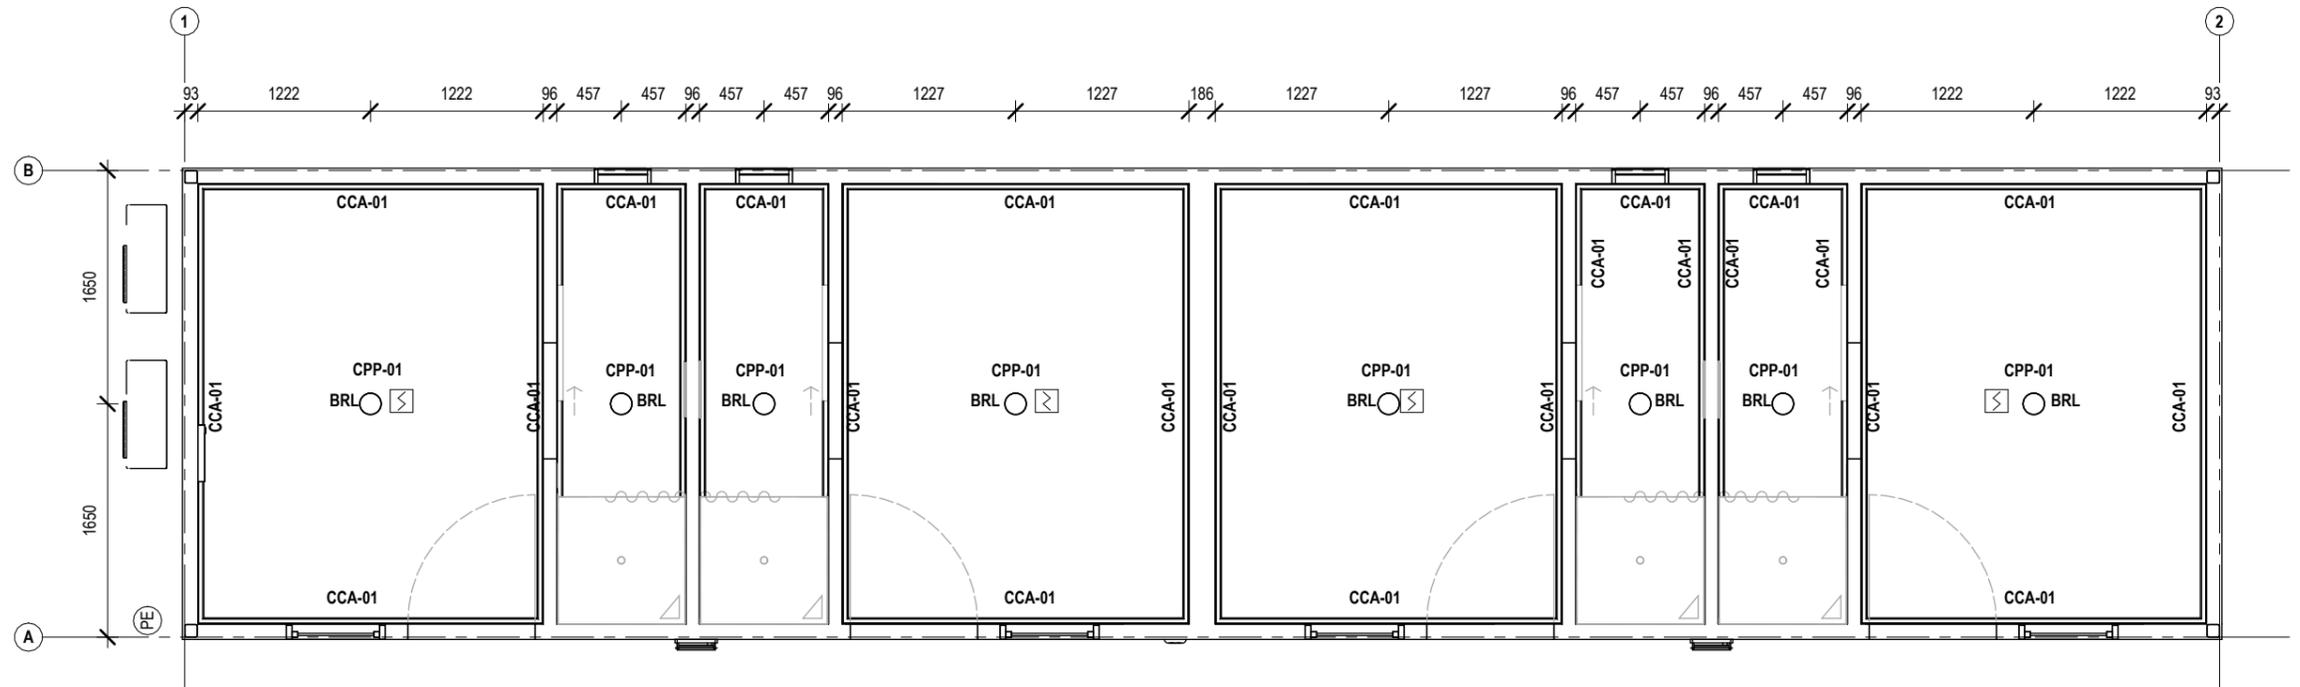
1 REFLECTED CEILING PLAN
1:50

ALL CEILINGS TO BE 2400MM HIGH UNLESS NOTED OTHERWISE

CEILING FIXTURES GENERALLY TO BE CENTRED WITHIN ROOMS UNLESS NOTED OTHERWISE

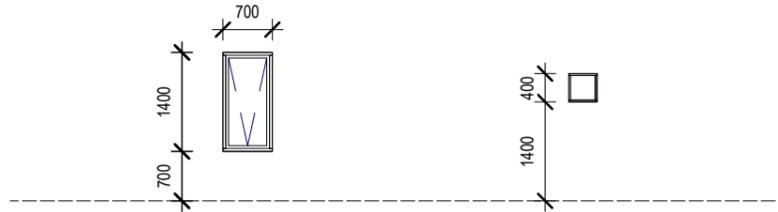
TYPE W1
 FRAME: POWDERCOAT ALUMINIUM DEEP OCEAN
 OPERATION: AWNING
 GLAZING: 5mm TOUGHEND

TYPE W2
 FRAME: POWDERCOAT ALUMINIUM DEEP OCEAN
 OPERATION: FIXED
 GLAZING: 5mm TOUGHEND OBSCURE

WINDOWS REQUIRE TO BE KEY LOCKABLE AS SCHEDULED.

FLYSCREENS TO ALL OPERABLE WINDOWS.

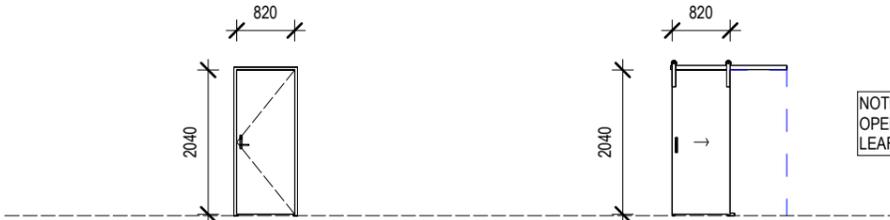
NOTE: DIMENSIONS ARE TO OPENING IN FRAME. DOOR LEAF TO BE 100mm WIDER

TYPE D1
 FRAME: GALV. PRESSED METAL POWDERCOATED DEEP OCEAN
 LEAF: METAL CLAD, SOLID TIMBER PANEL. COLORBOND EXT DEEP OCEAN, INT DEEP OCEAN.
 TYPE: HINGED DOOR
 HARDWARE: LEVER TYPE ENTRANCE SET

ALL DOORS WILL BE CONTRASTING TO FRAMES IN ACCORDANCE WITH AS1428.1 - 2009

MIN. 530MM LATCH CLEARANCE FROM THE EXTERNAL SIDE OF BOTH ENTRY DOORS.

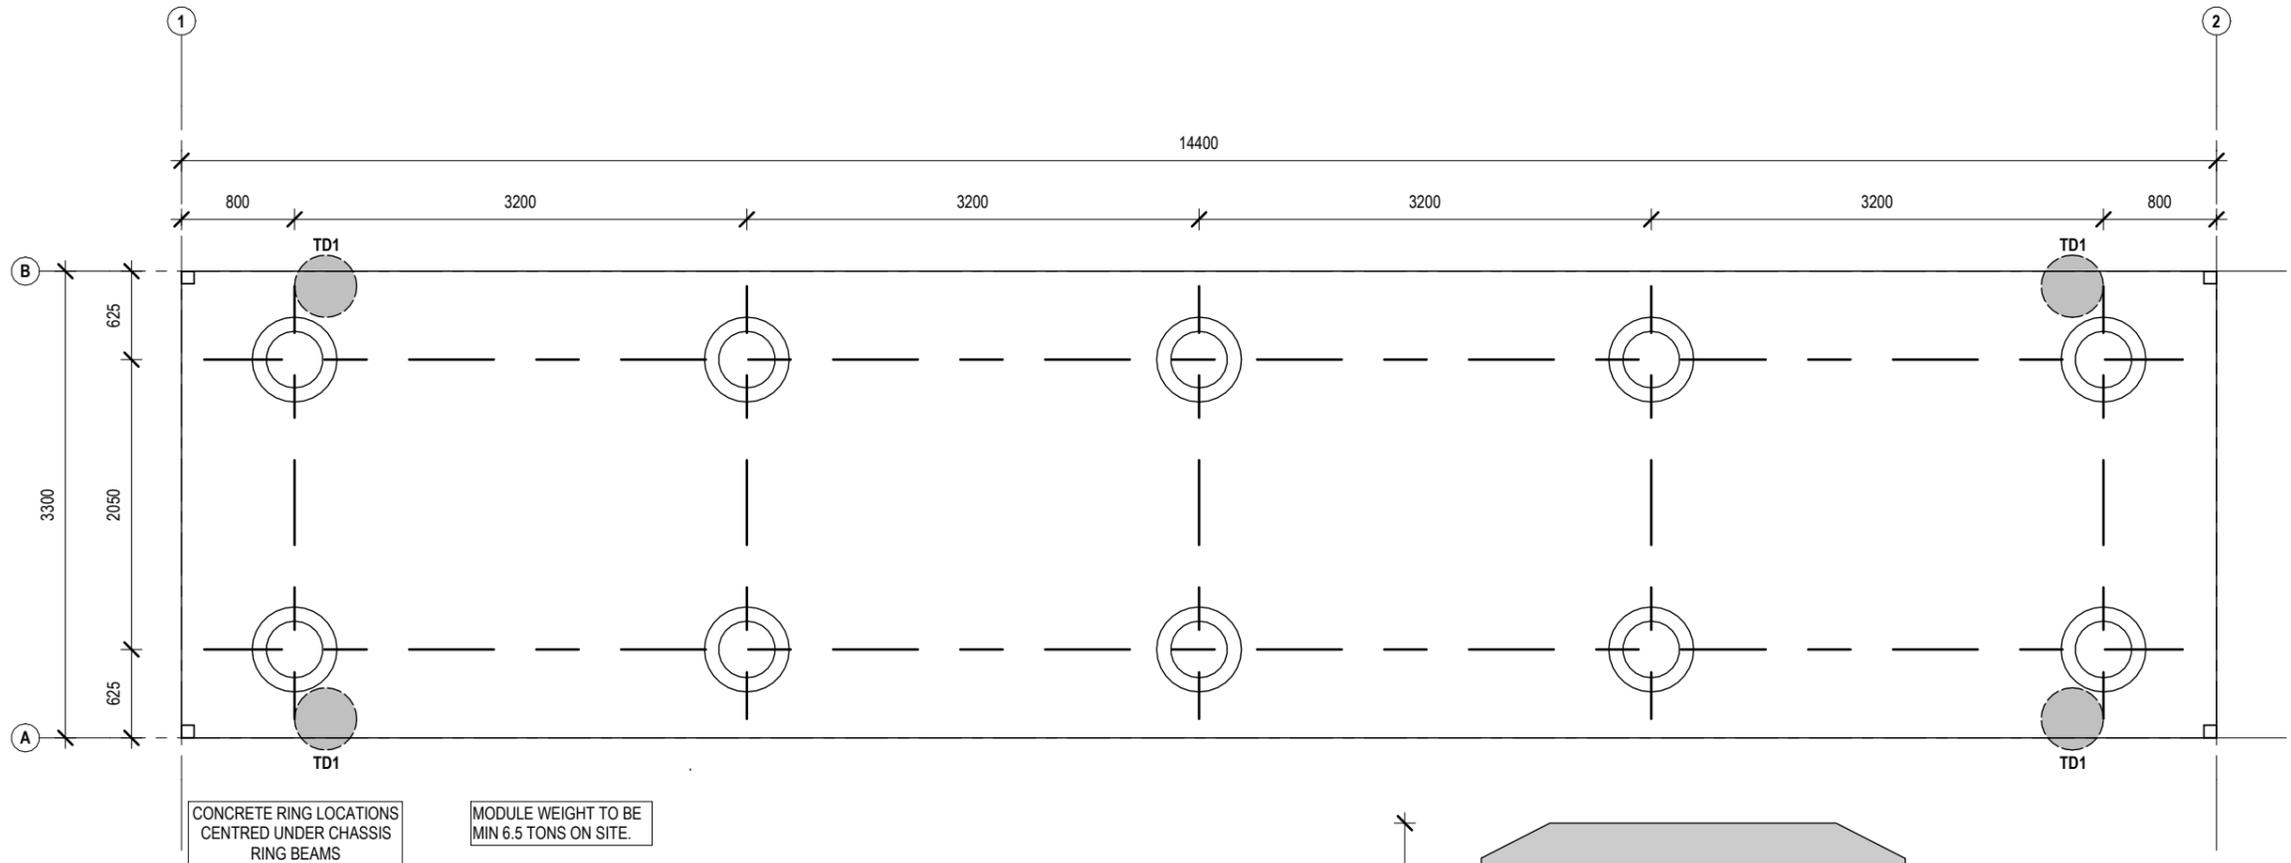
1 FOOTING LAYOUT
1 : 50

PRECAST CONCRETE SLAB BY TOHERS DESIGNED FOR 3kPA, 4.5kN IMPOSED FLOOR LOAD

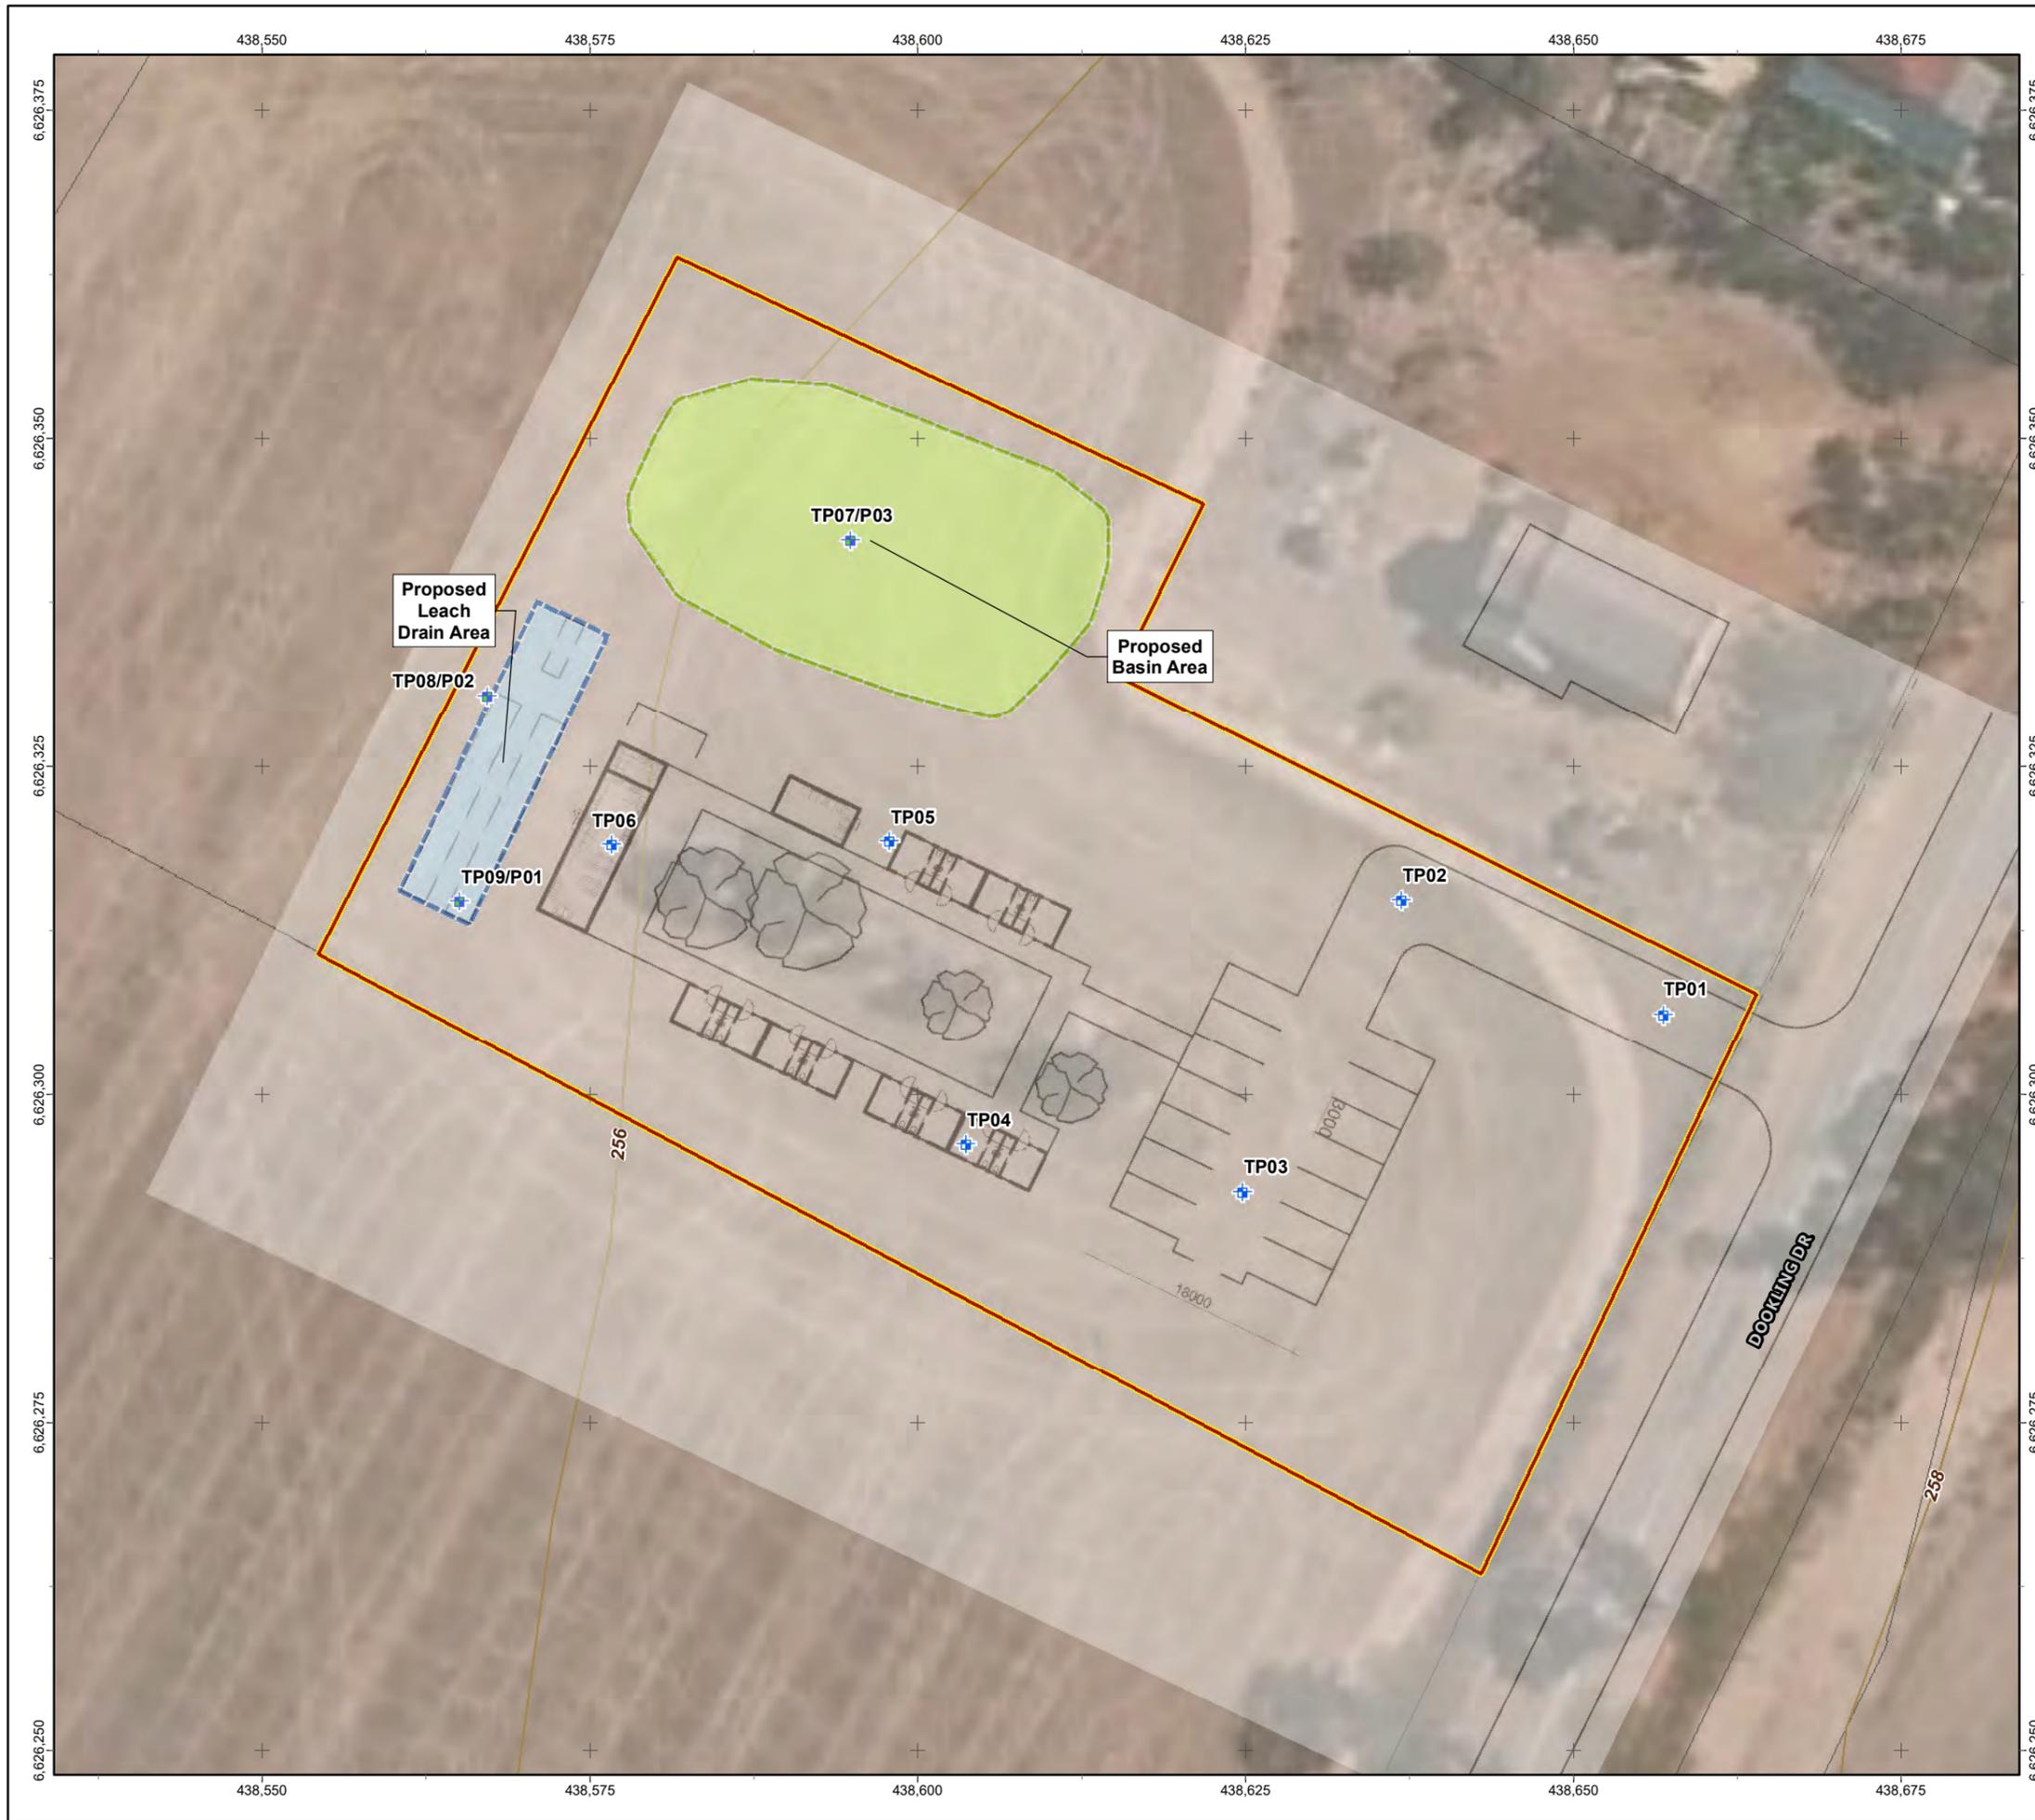
Figures

- Site Boundary
- + Test Pit
- + Test Pit / Constant Head Permeameter Test

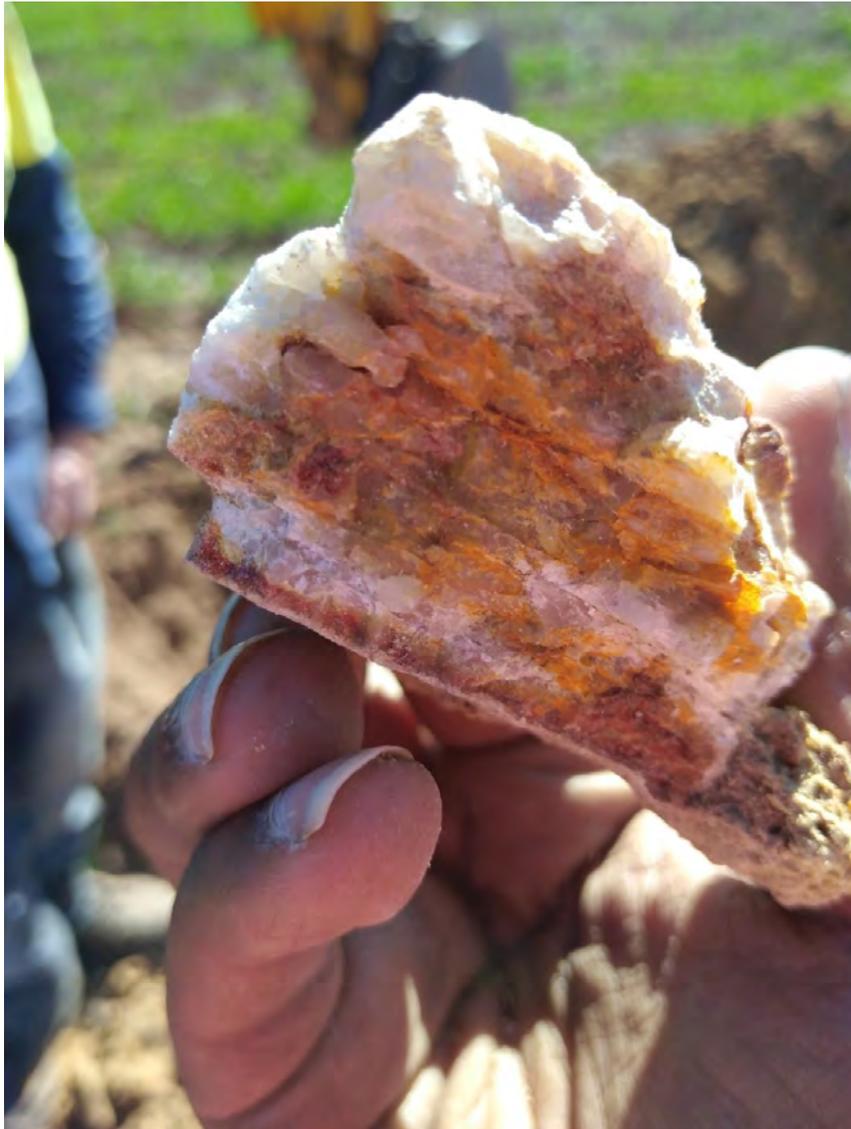
Photograph 13: Close up of cemented clayey soil interbedded with weathered rock within TP07 (depth 1.5 m)

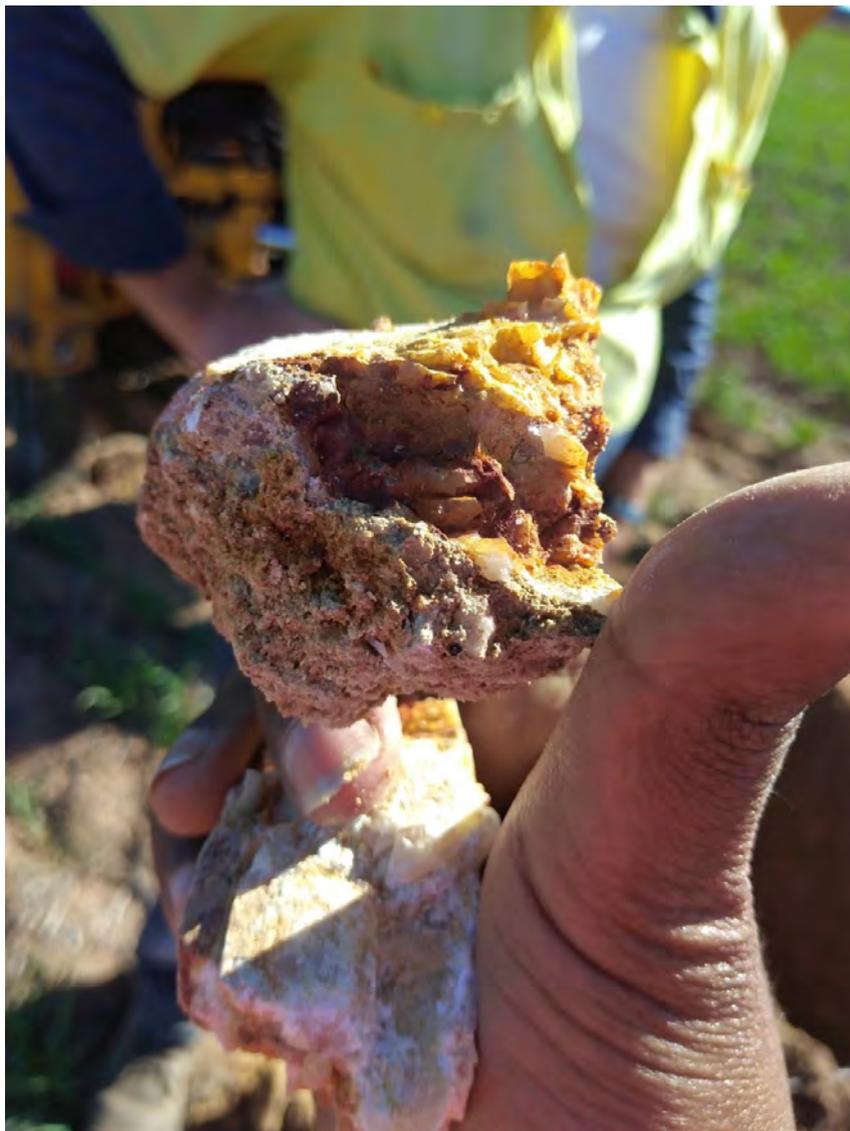
Photograph 14: Close up of cemented clayey soil interbedded with weathered rock within TP07 (depth 1.5 m)

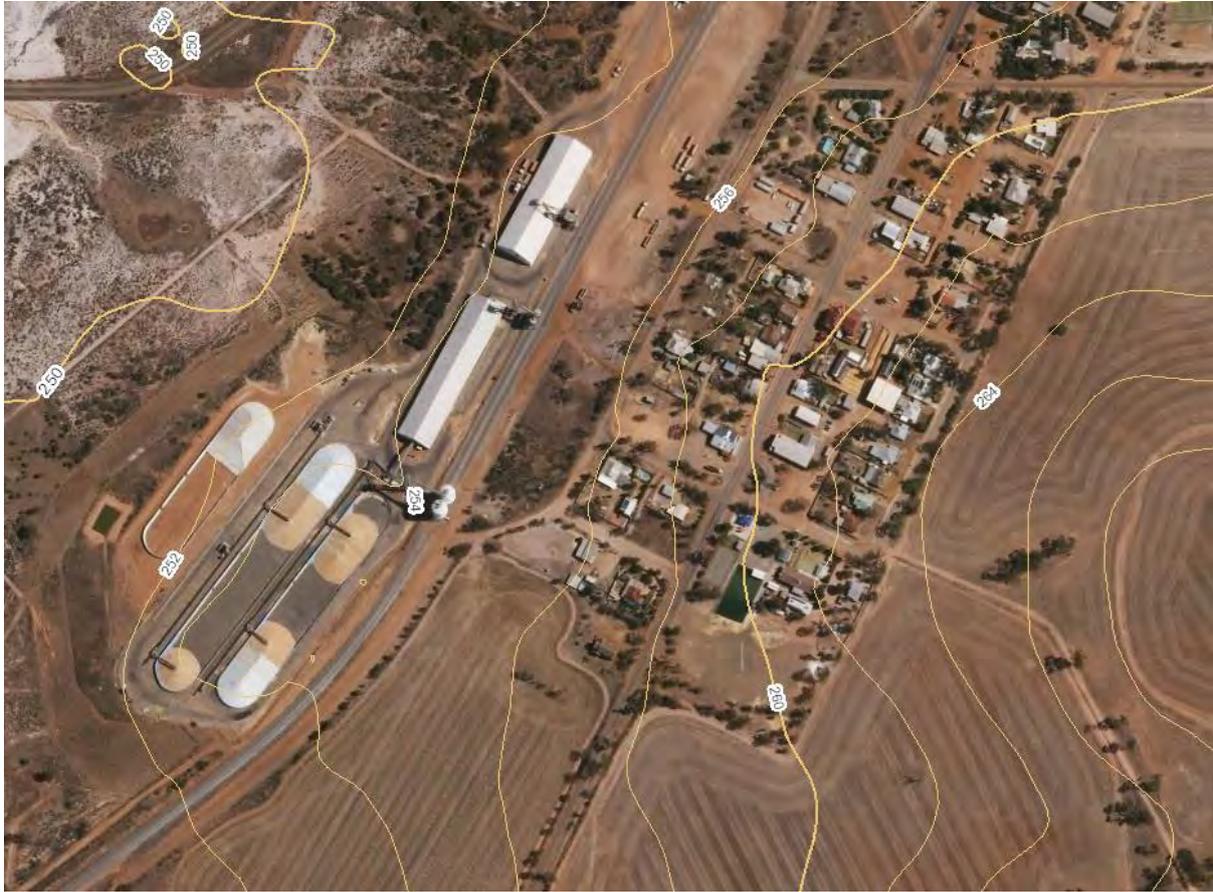
Figure 3: Aerial of Existing Infrastructure (Source: Landgate Locate)

The CBH Miling site is located on the western side of the Miling Town. The existing site currently has 105,000 tonnes of storage capacity split between three open bulkheads and two horizontal storage facilities and infrastructure for marshalling, sampling, and weighing, Refer to Figure 3.

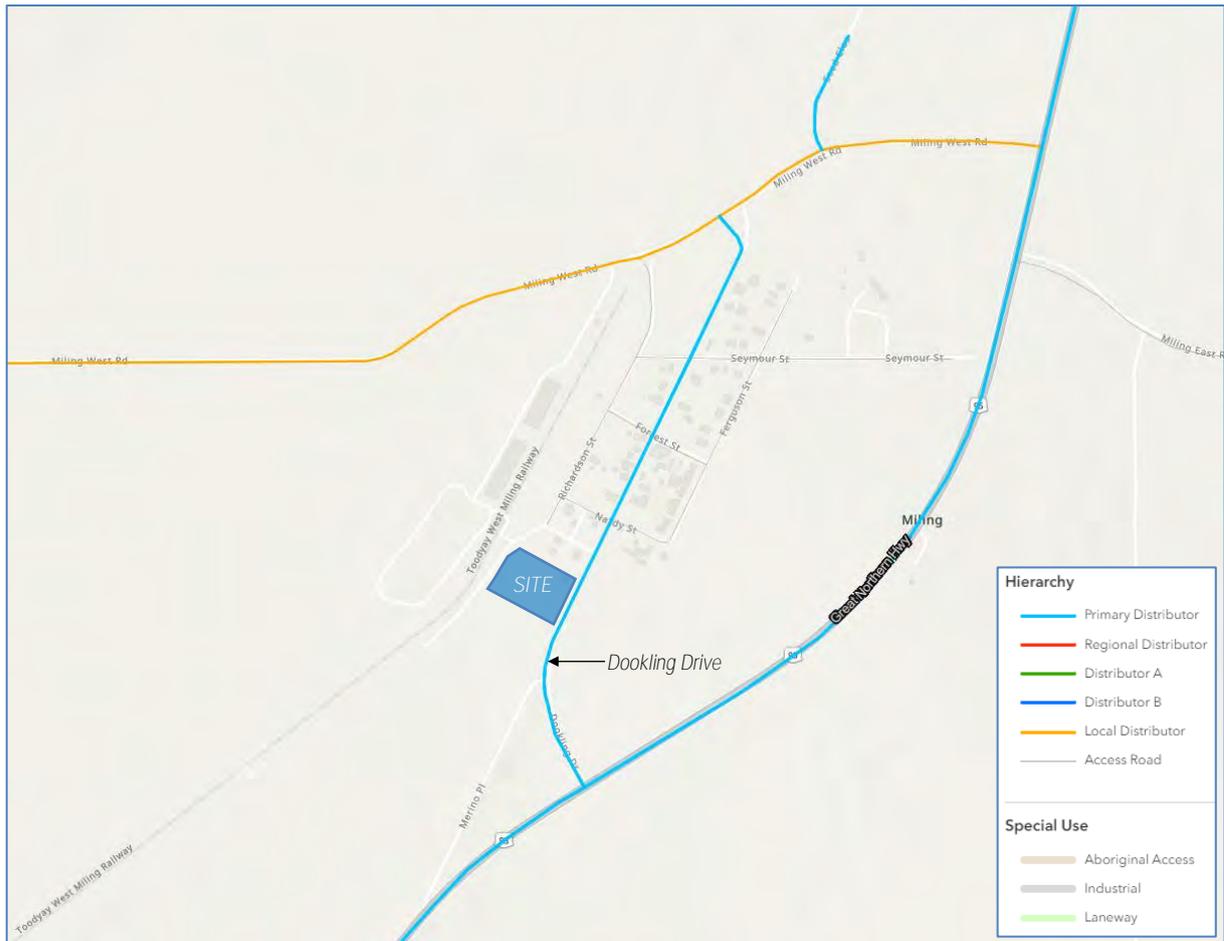
Figure 4: Existing Road Network Hierarchy

The layout and hierarchy of the existing local road network according to the Main Roads WA *Road Information Mapping System* is shown in Figure 4.

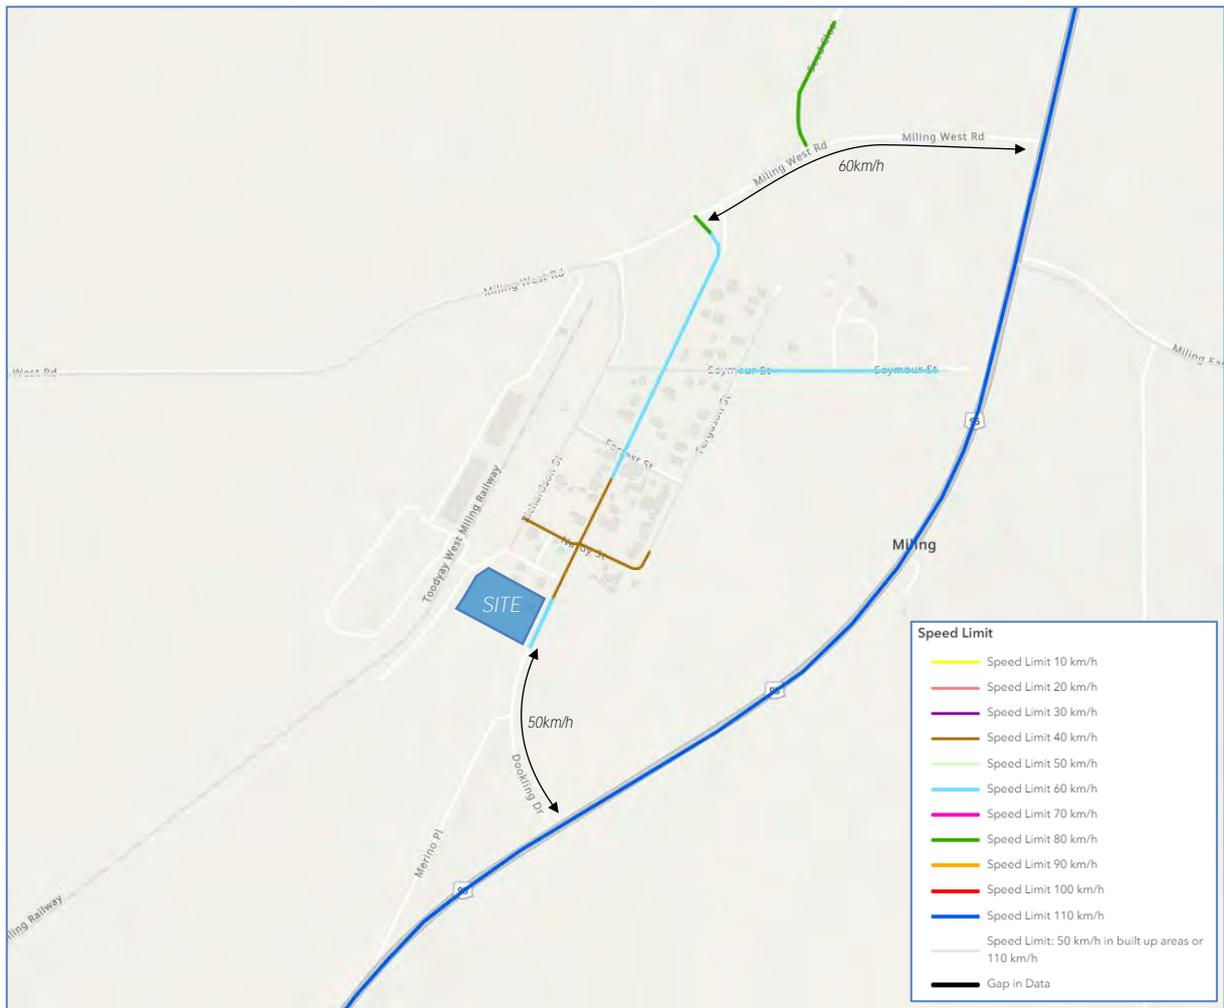
Figure 5: Existing Speed Limits

The speed limits are shown in Figure 5. As shown, there are some gaps in the speed data. Based on Google Street View, the speed limit on the southern section of Dookling Drive is 50km/h and the speed limit on Milling West Road west of Great Northern Highway is 60km/h.

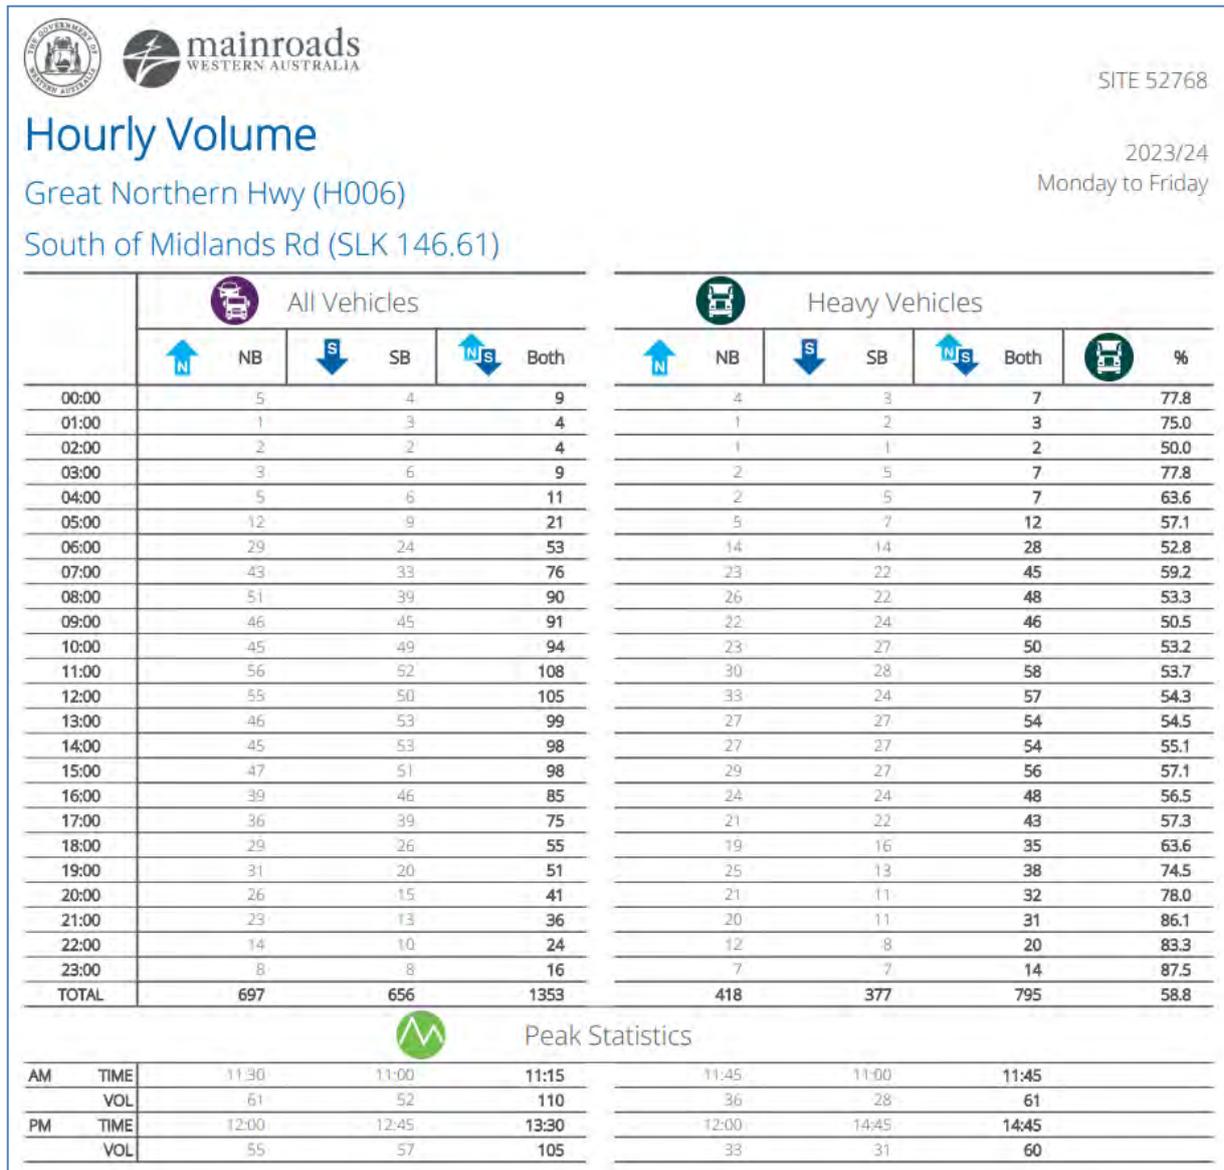
Figure 6: Traffic Volumes – Great Northern Highway south of Midlands Road – Average Weekday

The latest traffic volumes along Great Northern Highway were obtained from Main Roads WA *Traffic Map* as summarised in Figure 6 to Figure 9. There was no traffic data in the immediate vicinity of Miling and so the data shown are from Network Performance Sites (NPS) on Great Northern Highway on either side of Miling as a general indication of traffic.
