**SHIRE OF MOORA
LOCAL PLANNING SCHEME NO.4**

NOTICE OF PUBLIC ADVERTISEMENT OF PLANNING PROPOSAL

Lot 80 (No.18201) Great Northern Highway, Miling

CHANGE OF USE TO WORKFORCE ACCOMMODATION AT LOT 80 (NO. 18201) GREAT NORTHERN HIGHWAY, MILING

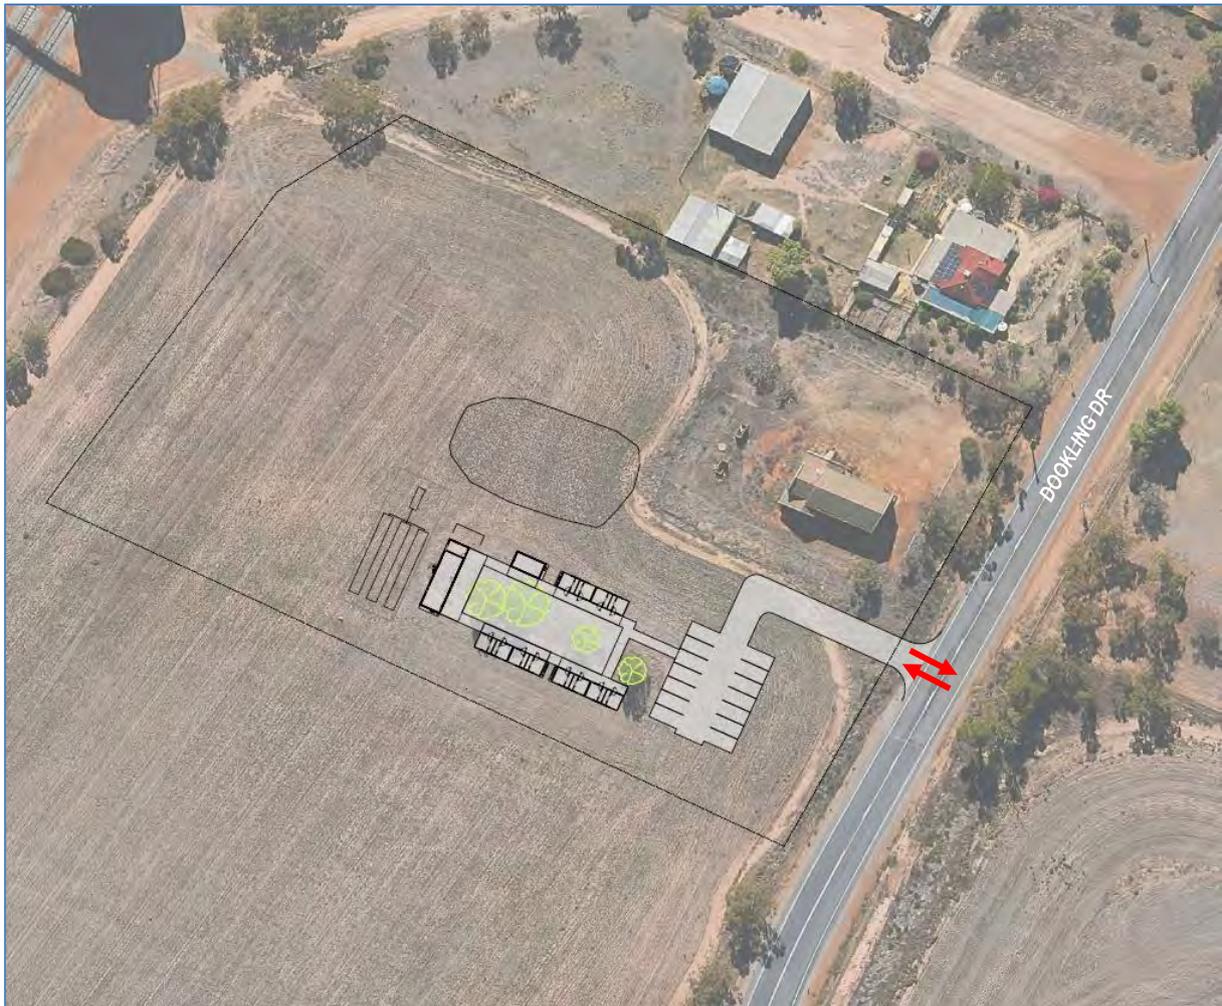
Figure 10: Vehicle Access Arrangement

Vehicle access to the site is proposed via a new driveway and crossover on Dookling Drive as shown in Figure 10.

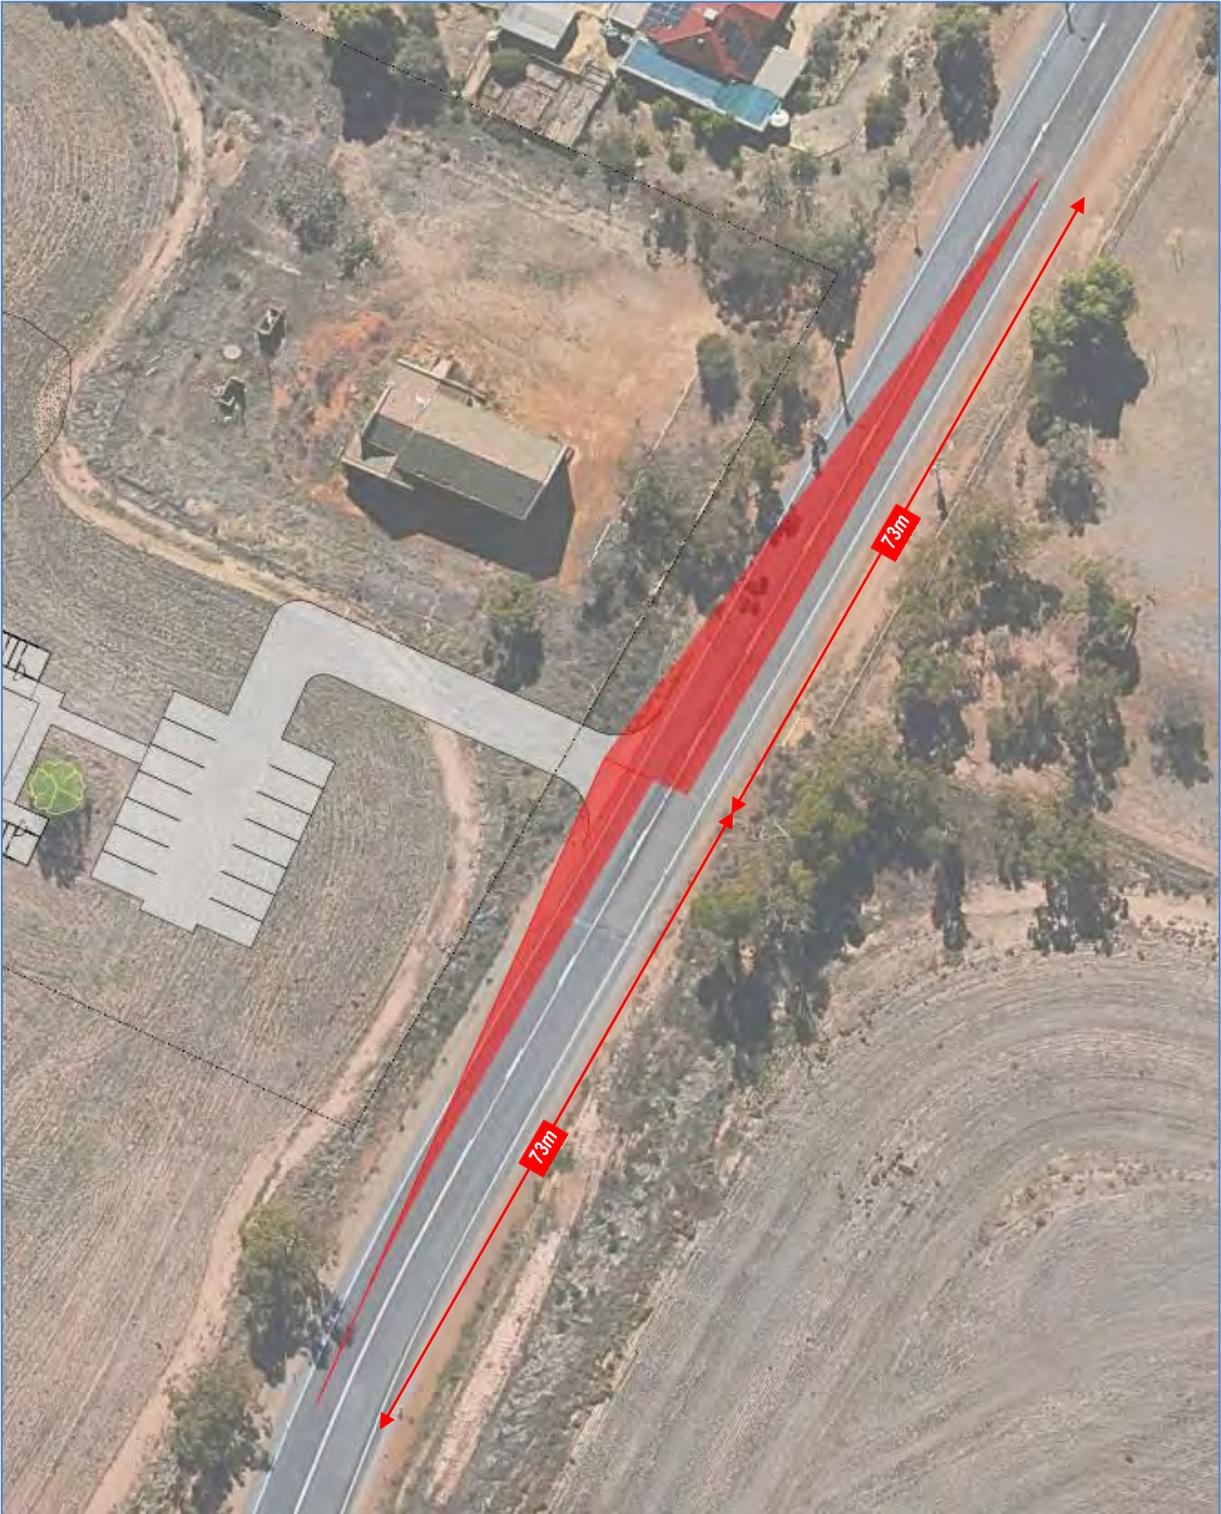
Figure 11: Sight Distance Check – Dookling Drive

Vertically, the alignment of Dookling Drive is relatively flat with no major crests or sags that impact sight distance.
