Scope of Works Proposal Ref: GSQU-0366

Shire of Moora

Pump Station 5 Pressure Main Reline

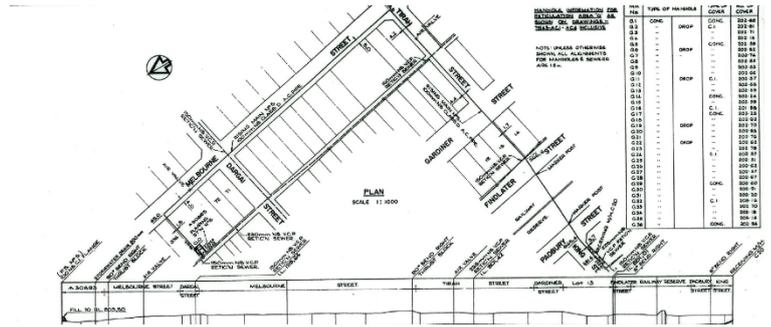
Following testing of the DN100 AC pressure main leading from wastewater pump station 5 it was found that the pipe is in very poor condition. Goodstream proposes to install an internal pipe liner to extend the life of the pipe to a minimum design life of 50 years.

A section of the pipe runs underneath industrial rail between Findlater St and Padbury St leading to the discharge chamber.

A sense of priority would be to start by rehabilitating the pipe section from the discharge chamber to the fence line of the properties backing onto Findlater St. This is due to the impact on the rail in the chance event there was a failure of the pressure main. Approximately 125m of AC pipe.
